Expert Witness Report

Thomas P. Ciarametaro
Five Fathoms Consulting LLC
June 14th, 2024

No. 1:23-CV-00853-DAE
United States District Court
Western District of Texas - Austin Division

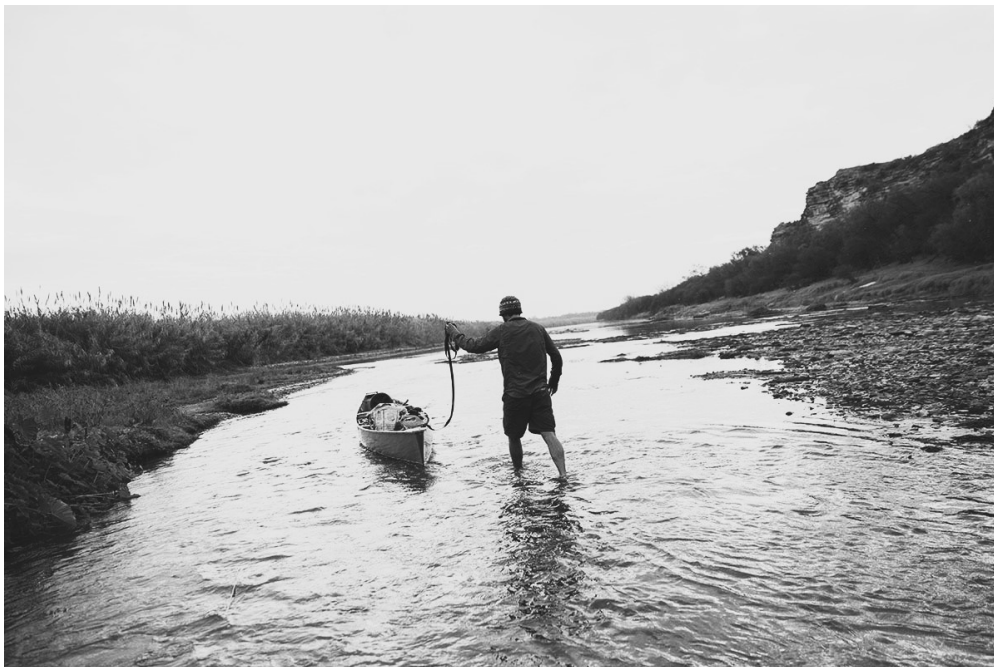
Figure 4. Expedition member dragging a canoe down the Rio Grande River in in an ankle-deep water. *Id.*

Cpt. Ciarametaro found similar conditions from his review of a video recording between Mile Markers 275.5 and 610 and during a site visit on June 7, 2024, to the area near Eagle Pass, TX.

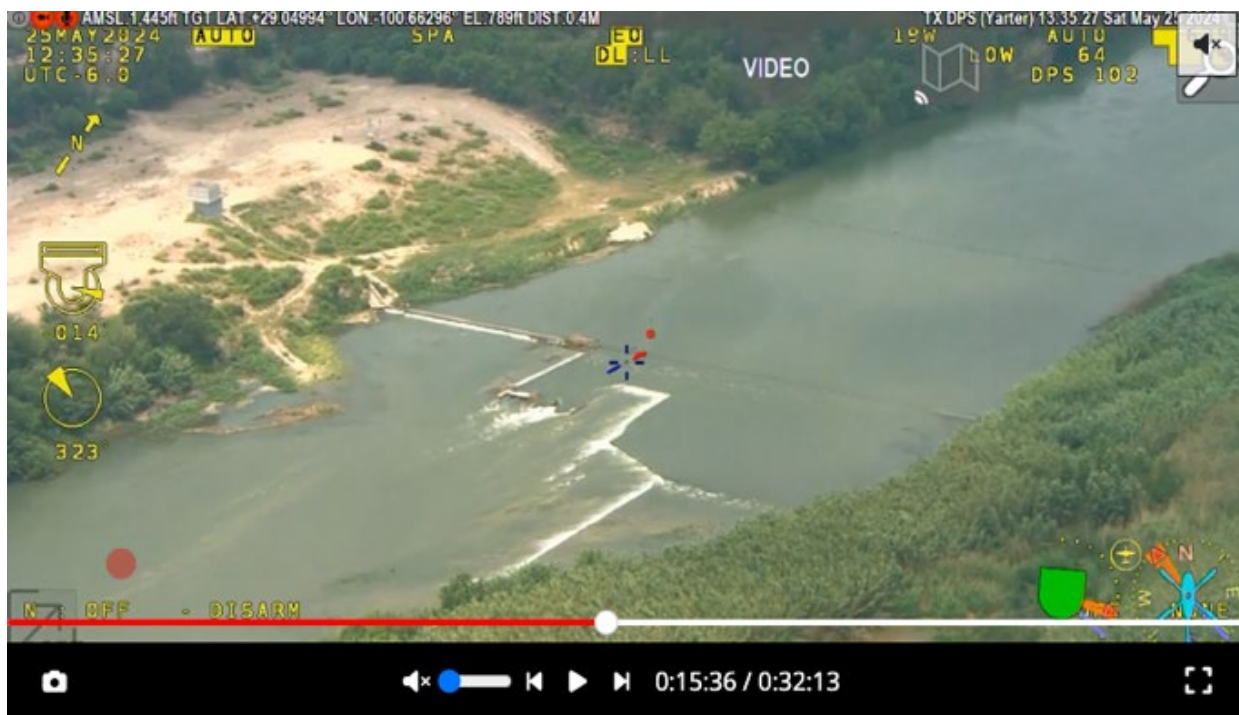
Figure 7. Image showing impassable water conditions.

Cpt. Ciarametaro observed *numerous* locations that were impassible to Class A and Class 1 vessels, small vessels, and any vessel or barge carrying commercial cargo, including but not limited to the following images and their corresponding time stamps:

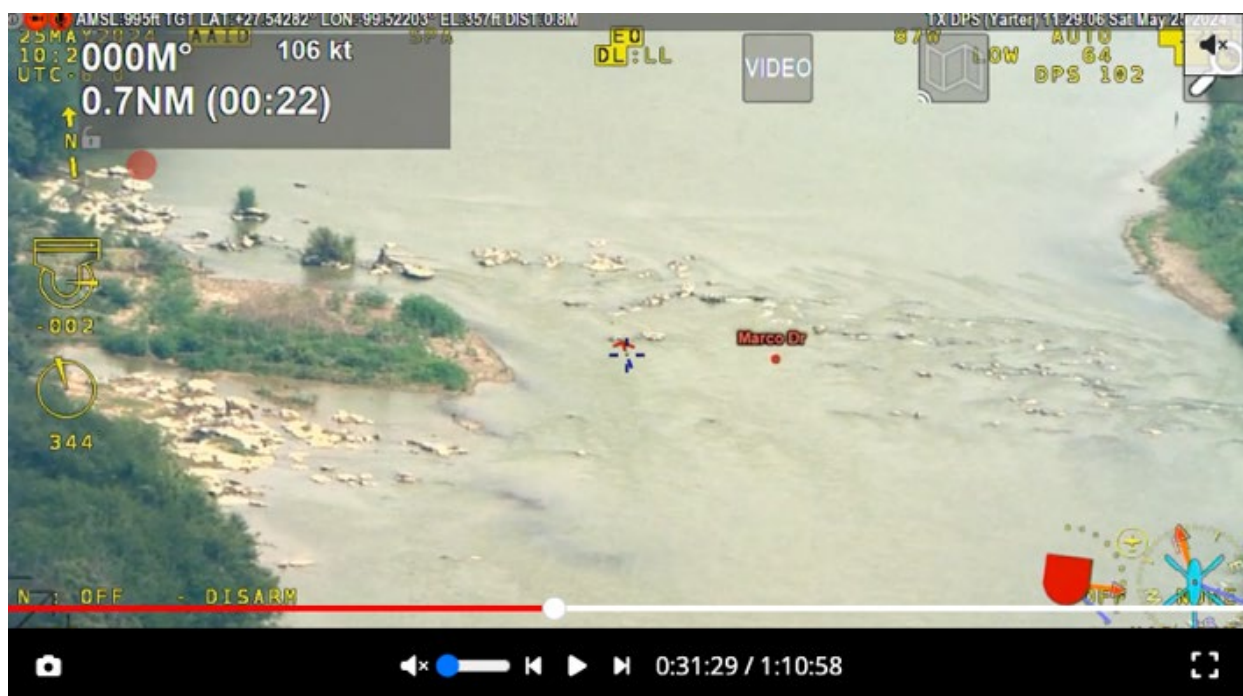
Figure 8. Image showing impassable water conditions.

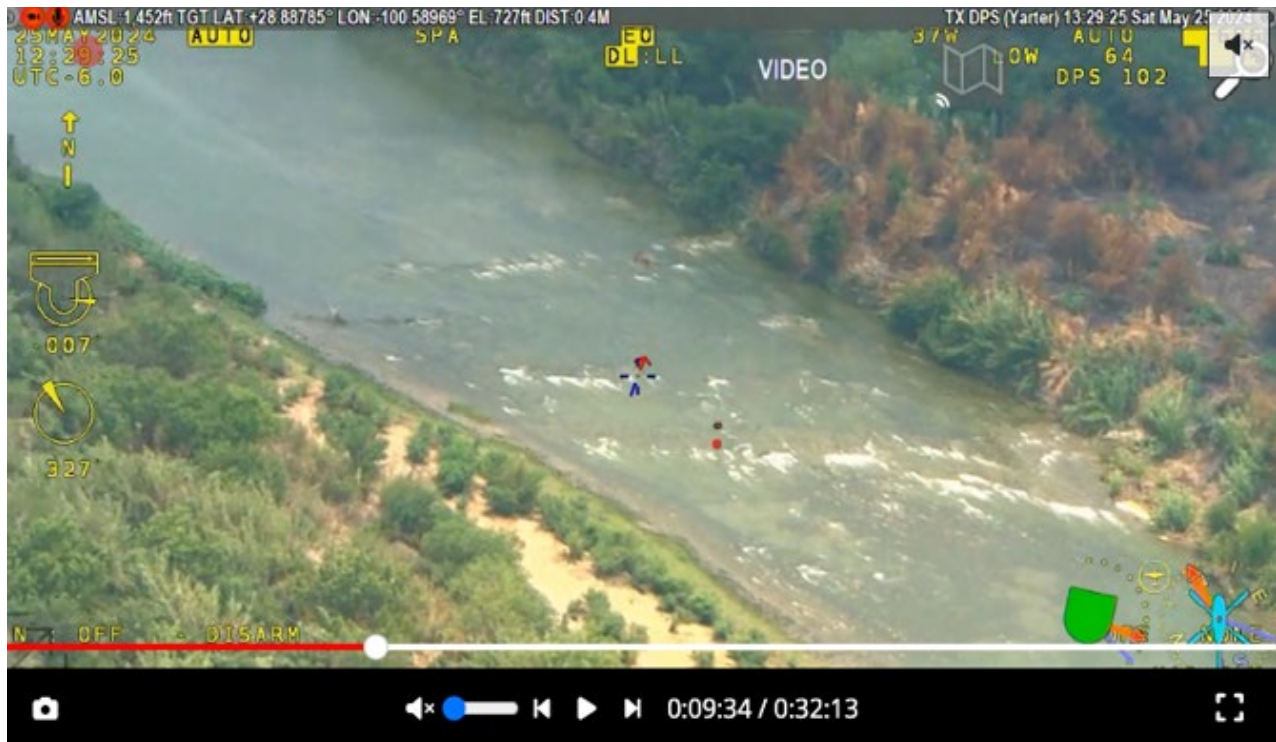
Figure 9. Image showing impassable water conditions.

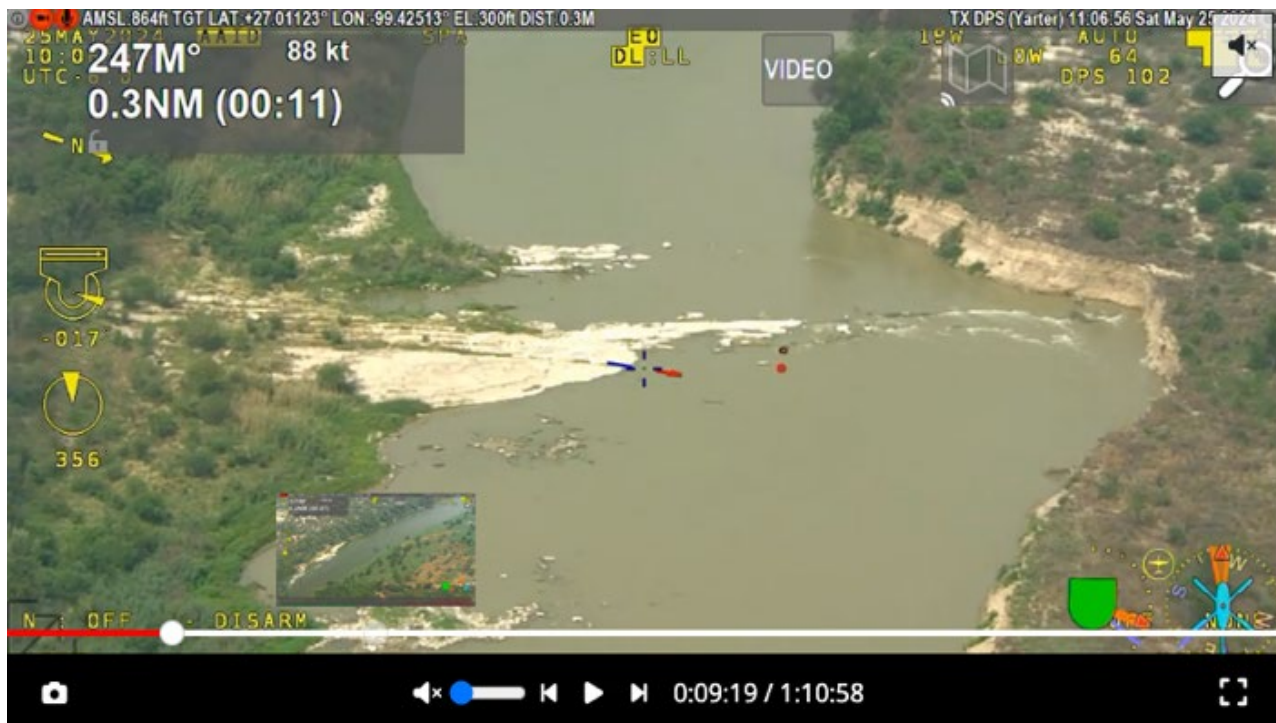
Figure 10. Image showing impassable water conditions.

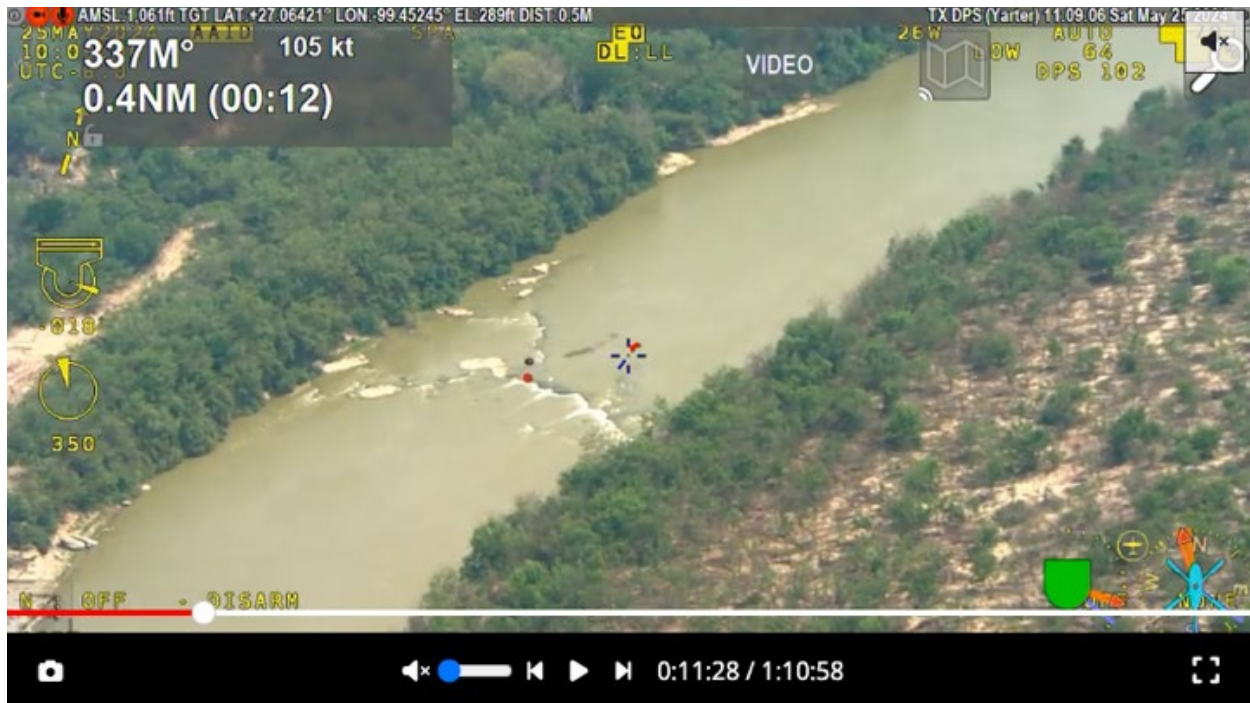
Figure 11. Image showing impassable water conditions.

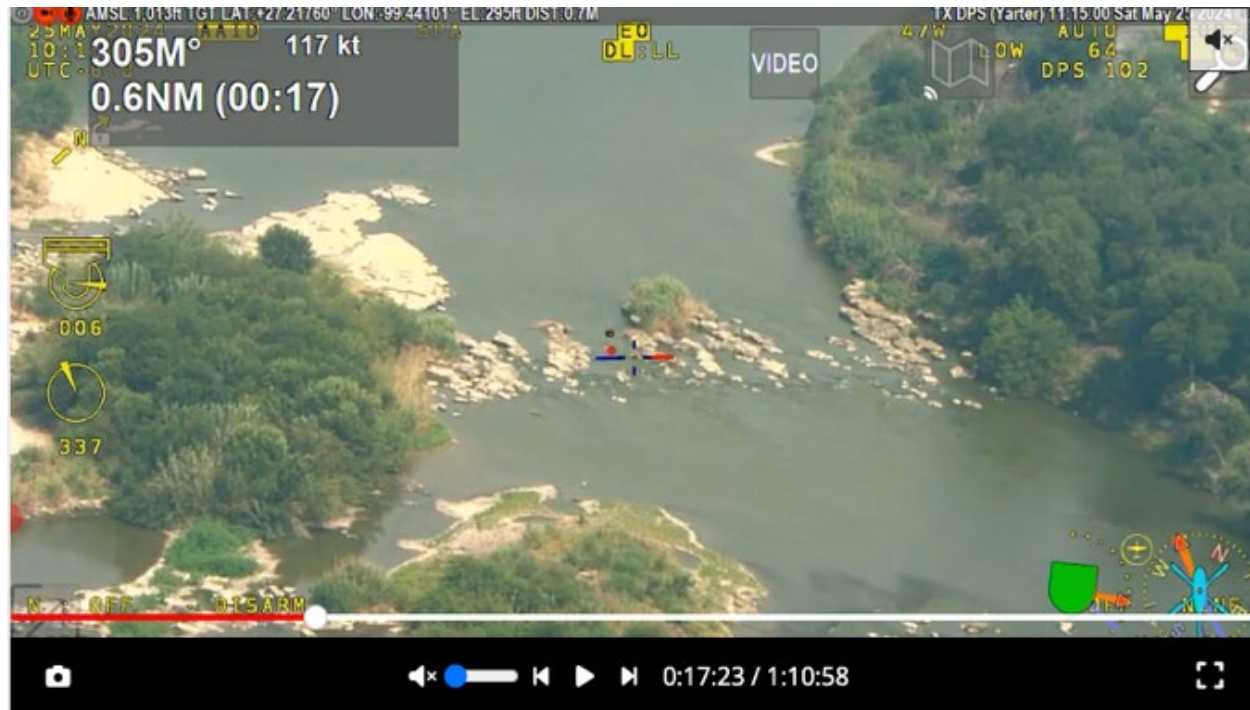
Figure 12. Image showing impassable water conditions.

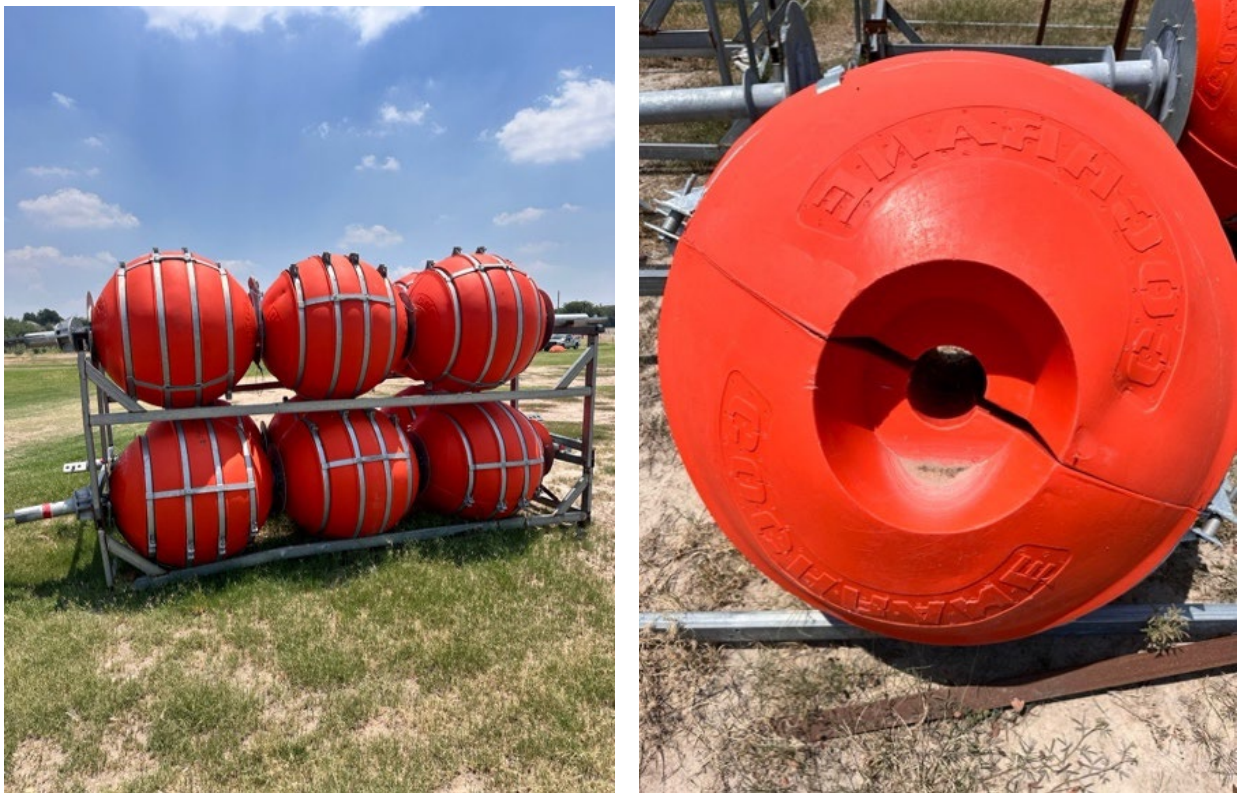
Figures 13 & 14. Pictures of the buoys.

The buoys in the Rio Grande River are a strategic barrier consisting of a series of connected, floating buoys placed along the river's eastern course along the Texas border that is intended to deter border crossings into the state and warning mariners of the concrete moorings to which they are attached that may be underneath the water, while still allowing unimpeded

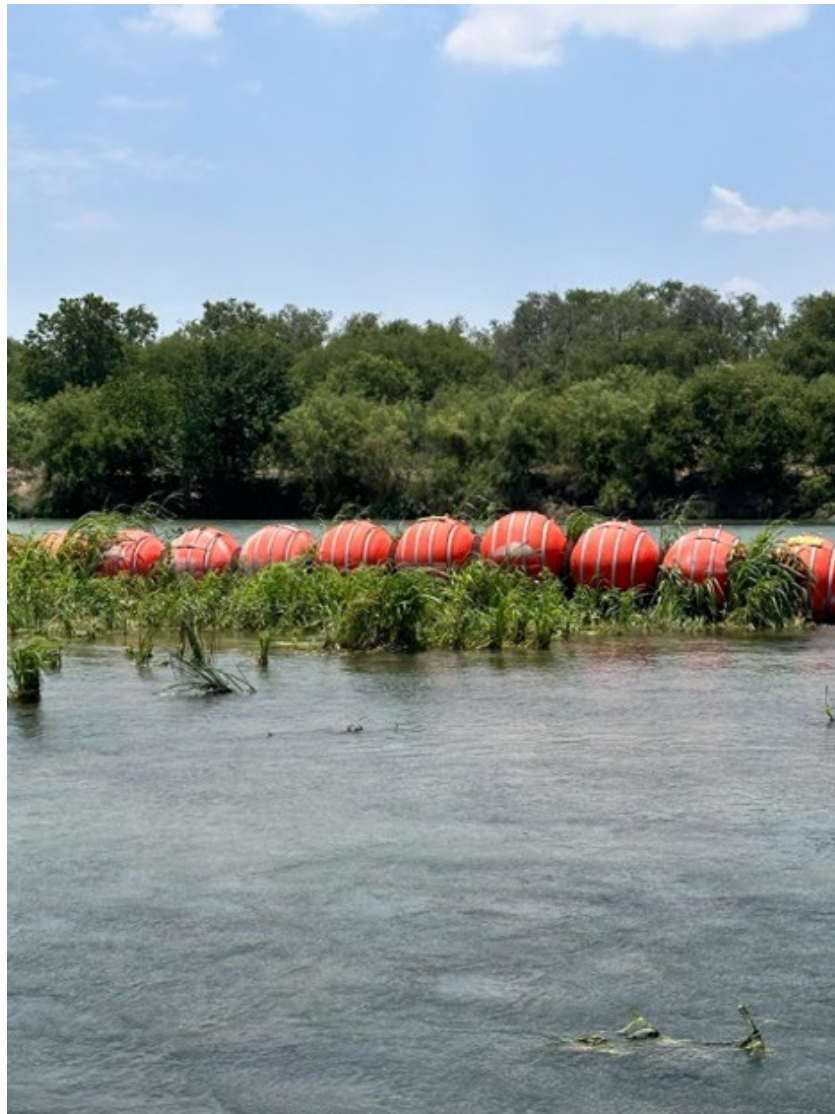
Figure 15. Pictures of the buoys taken by Cpt. Ciarametaro during site visit.

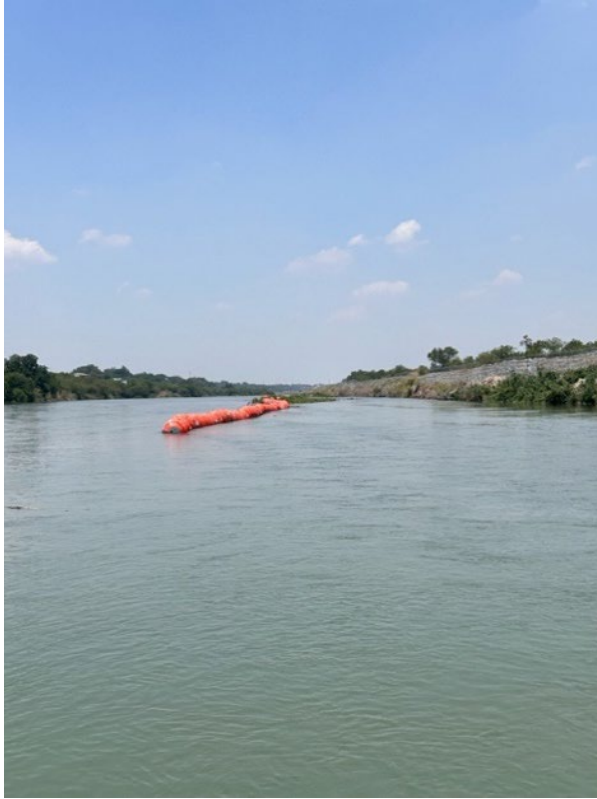
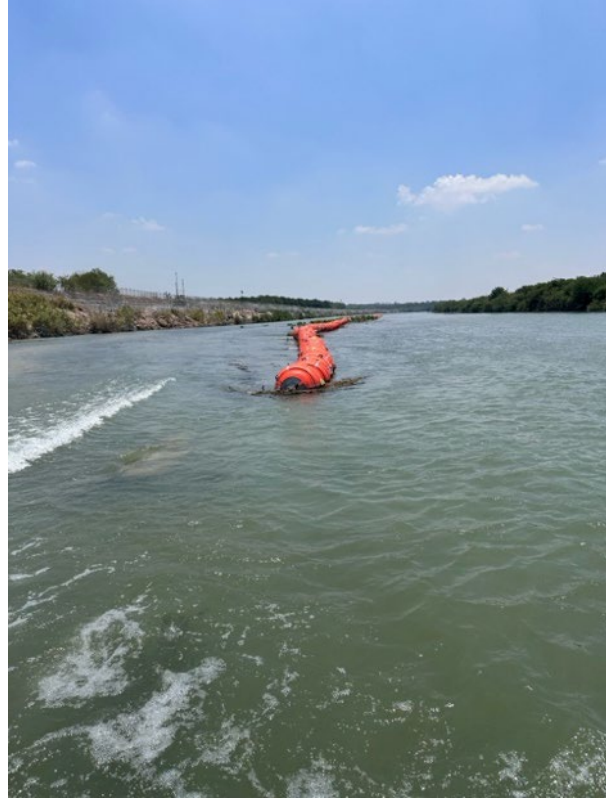
Figures 16 & 17. Pictures of the buoys taken by Cpt. Ciarametaro during site visit

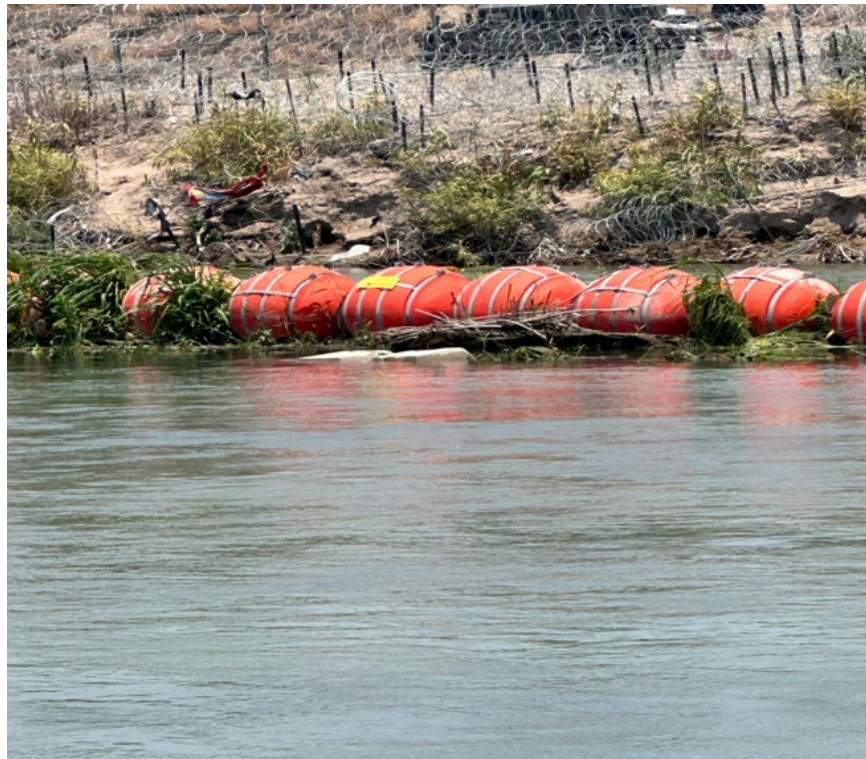
Figures 18. Pictures of the buoys taken by Cpt. Ciarametaro during site visit

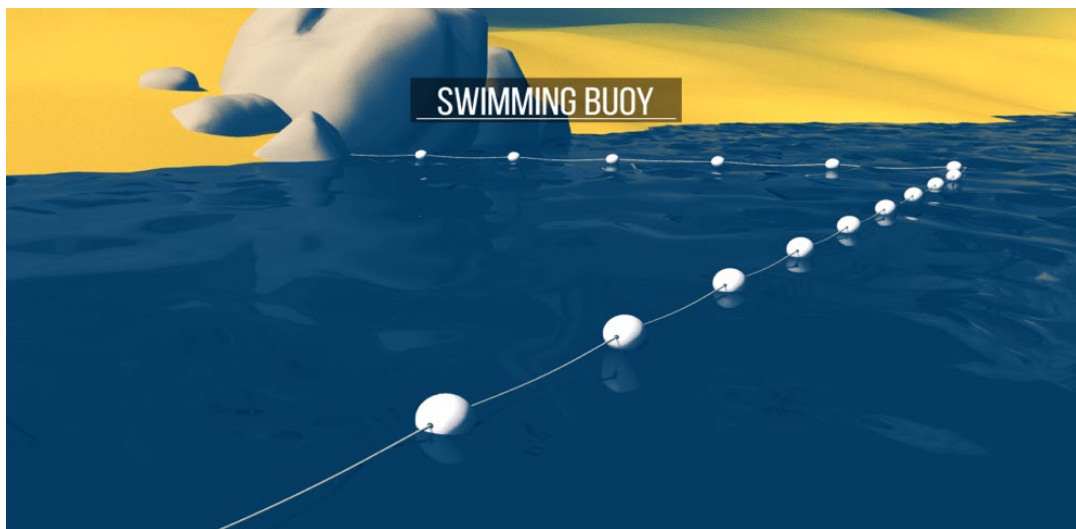
Figures 19. Example of a swim buoy system. *Characteristics of a swimming buoy*, AceBoater.com (accessed June 14, 2024), <https://tinyurl.com/4kv6ebhv>.

The barrier in Eagle Pass, Texas, is comprised of buoys rather than floats due to several defining characteristics and functions. Buoys are anchored devices used primarily for marking positions on the water and serving specific purposes such as navigation, mooring, or delineating boundaries. Unlike floats, which are typically movable objects without fixed positions, buoys are designed to remain stable and fixed in a specific location, often tethered to the seabed. This stability is crucial for the barrier's function in Eagle Pass. Moreover, the barrier is helpfully visible and thus serves the specific purpose of deterring illegal crossings and alerting mariners to their concrete moorings. Therefore, based on their anchored design, specific purpose, and practical application in marking boundaries, it is clear that the devices used in Eagle Pass are buoys and not floats.

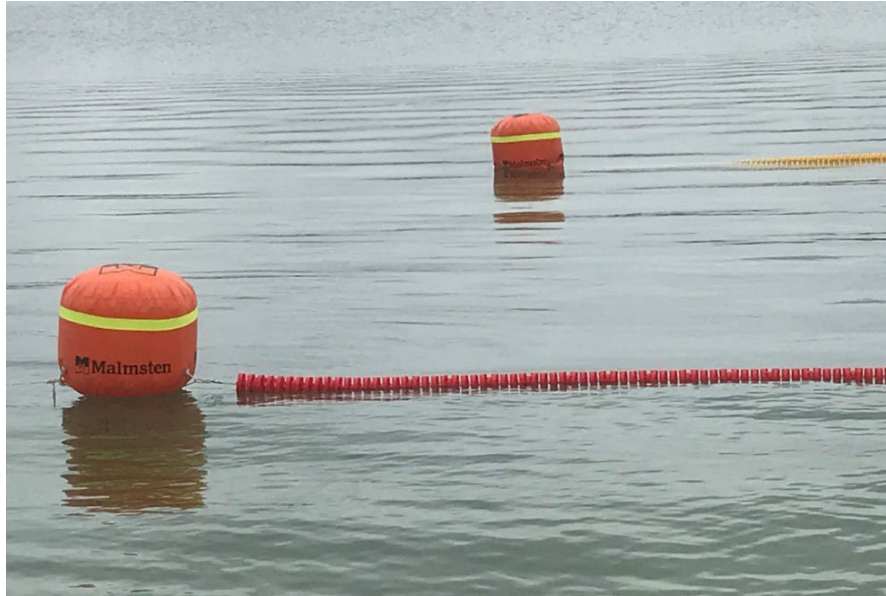
Figures 20. Another example of a swim buoy system. *Swim Course Marker Buoy*, Malmsten (accessed June 14, 2024), <https://tinyurl.com/ye244dnk>.

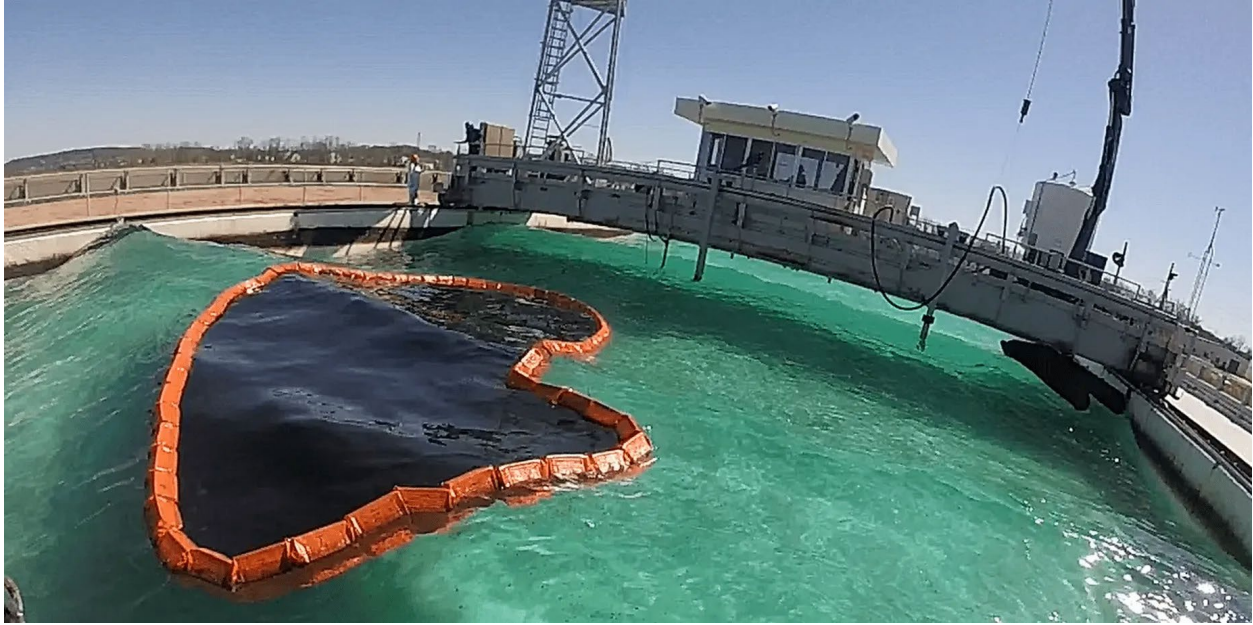
Figures 21. An example of a containment boom. *All About Oil Spill Containment Booms*, UltraTech Int'l (accessed June 14, 2024), <https://tinyurl.com/yc2r5m2n>.

Booms are often used in accidents, such as oil spills, as a means of containment.

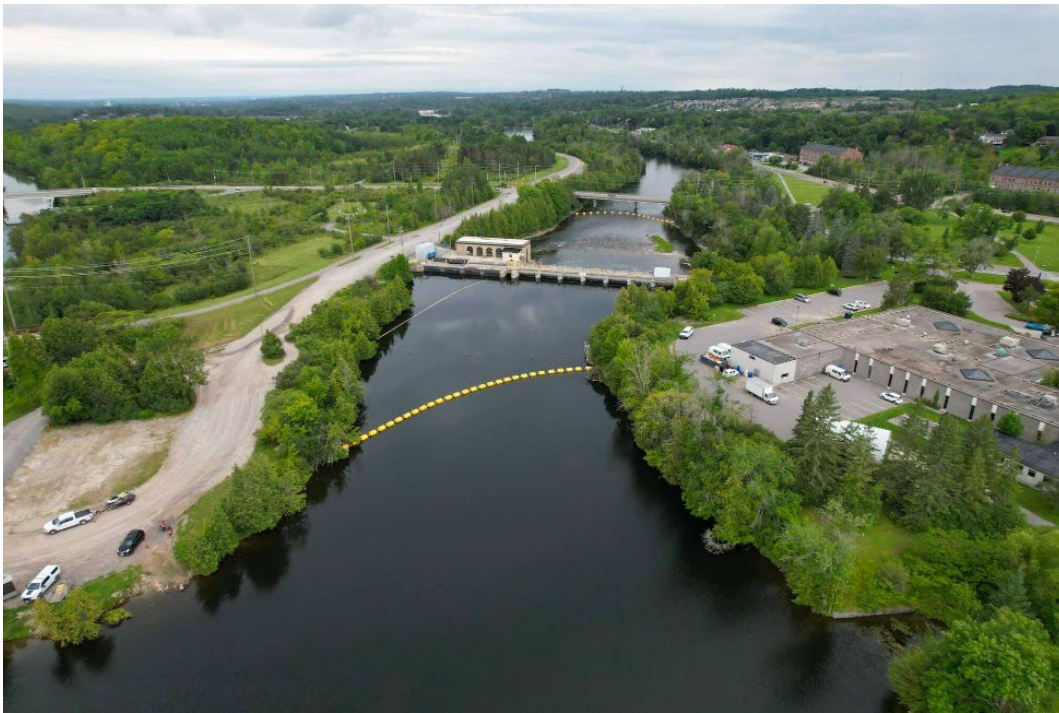
Figures 22. An example of a floating barrier obstructing the entire waterway. *OdinBoom, Floating Barriers*, Worthington Waterway Barriers (accessed June 14, 2024), <https://tinyurl.com/2rptc7ye>.

The buoys in this case are distinguishable from booms, as defined above, because they do not obstruct passage along the entire Rio Grande River.

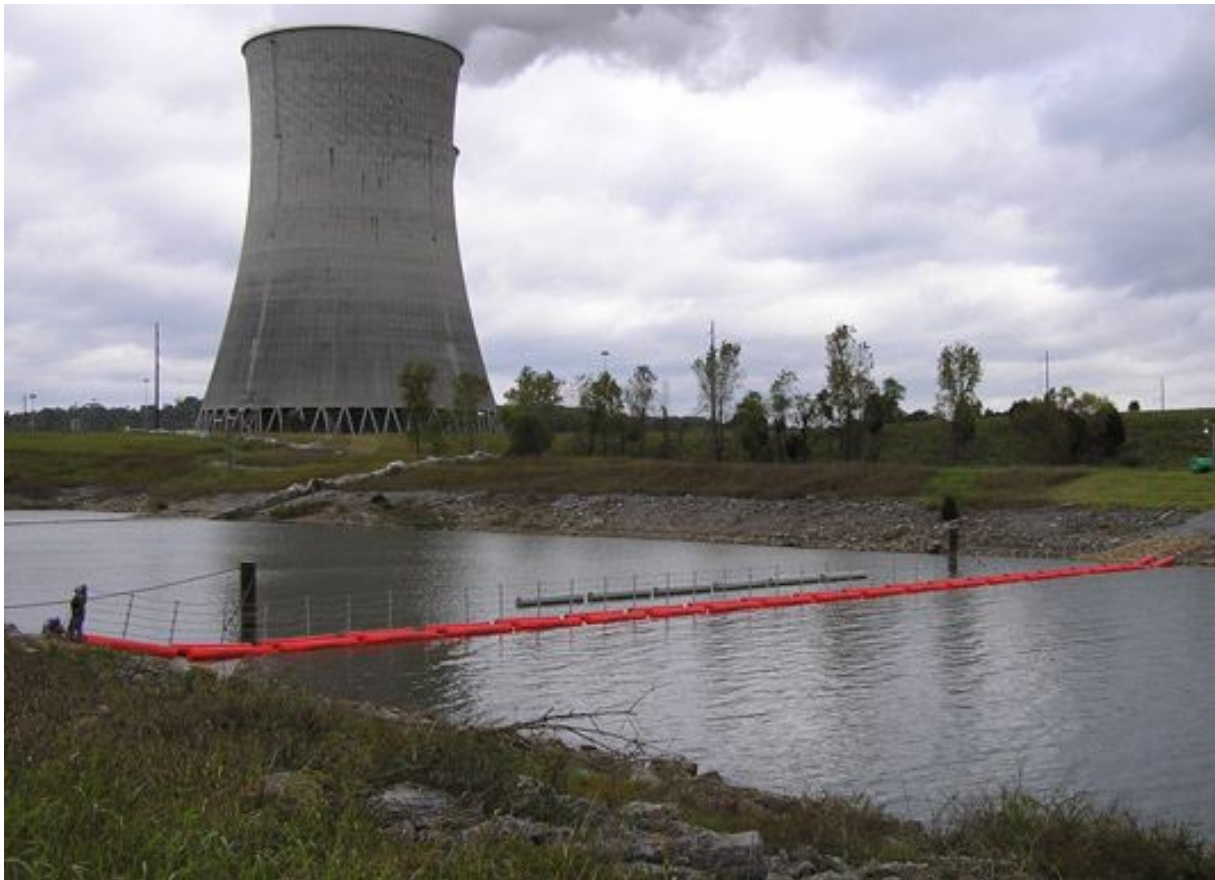
Figures 24. An example of a floating boom barrier obstructing the entire waterway. TuffCat, *Marine Security Barriers*, OFM Engineering (accessed June 14, 2024), <https://tinyurl.com/4smzwhxd>.

The buoys do not obstruct passage along the Rio Grande River, therefore, based on the definition provided, the buoys are not booms.
